MICROCHIP PIC18F2420/2520/4420/4520

PIC18F2420/2520/4420/4520 Rev. B3 Silicon Errata

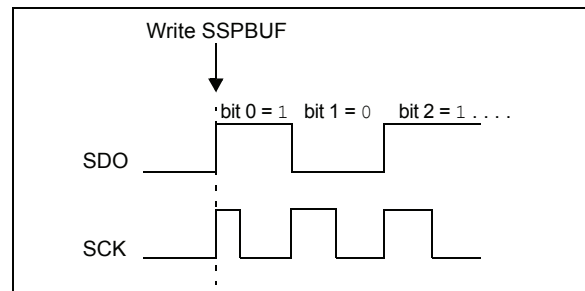
FIGURE 1: SCK PULSE VARIATION USING TIMER2/2

2. Module: MSSP (SPI Mode)

When the SPI is using Timer2/2 as the clock source, a shorter than expected SCK pulse may occur on the first bit of the transmitted/received data (Figure 1).

To avoid producing the short pulse, turn off Timer2 and clear the TMR2 register, load the SSPBUF with the data to transmit and then turn Timer2 back on. Refer to Example 1 for sample code.
