## PIC16(L)F18854 Family Silicon Errata and Data Sheet Clarification

The PIC16(L)F18854 family devices that you have received conform functionally to the current Device Data Sheet (DS40001826A), except for the anomalies described in this document.

**Note:** This document summarizes all silicon errata issues from all revisions of silicon, previous as well as current. Only the issues indicated in the last column of [Table 2](#) apply to the current silicon revision (**A1**).

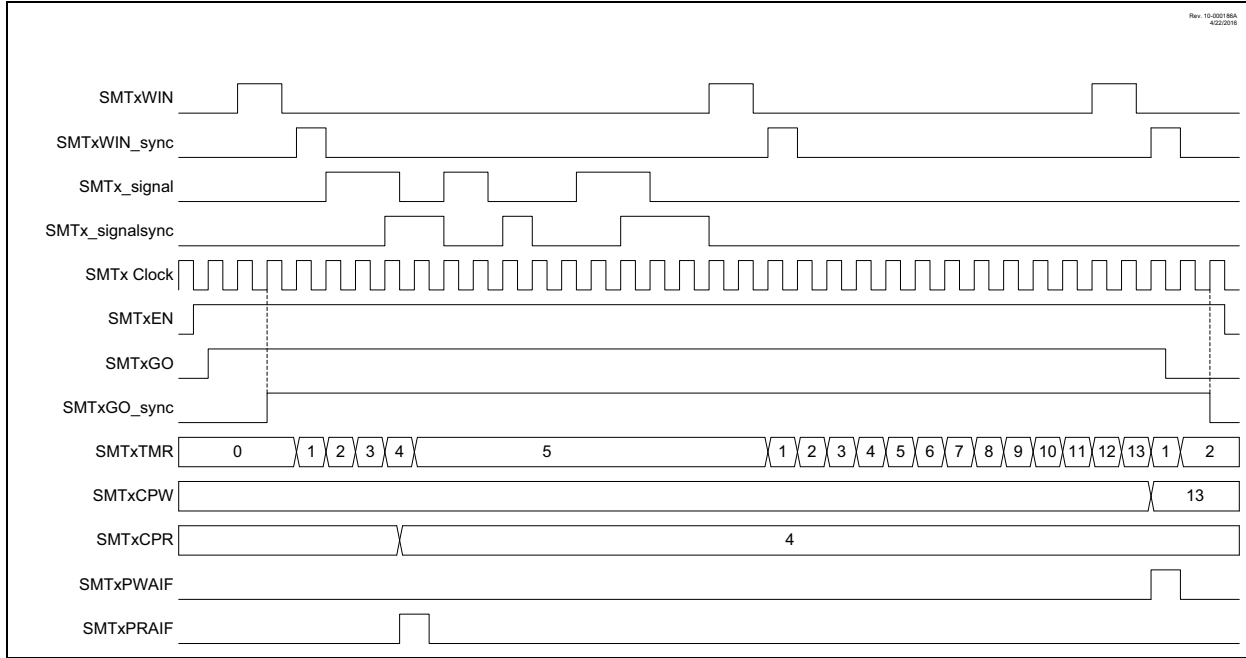
**FIGURE 32-14: TIME OF FLIGHT MODE REPEAT ACQUISITION TIMING DIAGRAM**

Several timing diagrams in the Signal Measurement Timer chapter (namely Figures 32-14, 32-15, and 32-18) contain inaccuracies. The correct versions of these timing diagrams are below.

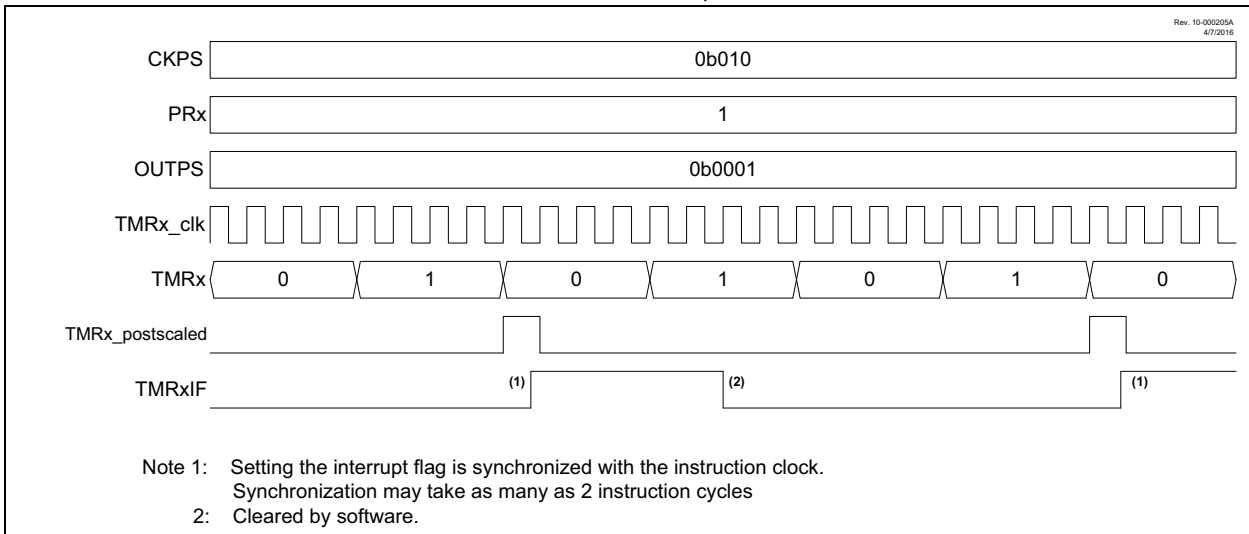
**FIGURE 29-3: TIMER2 PRESCALER POSTSCALER, AND INTERRUPT TIMING DIAGRAM**

Several timing diagrams in the Timer2/4/6 chapter (namely [Figure 29-3](#), as well as [Figures 29-8](#) through [29-13](#)) contain inaccuracies. The correct timing diagrams are shown below.

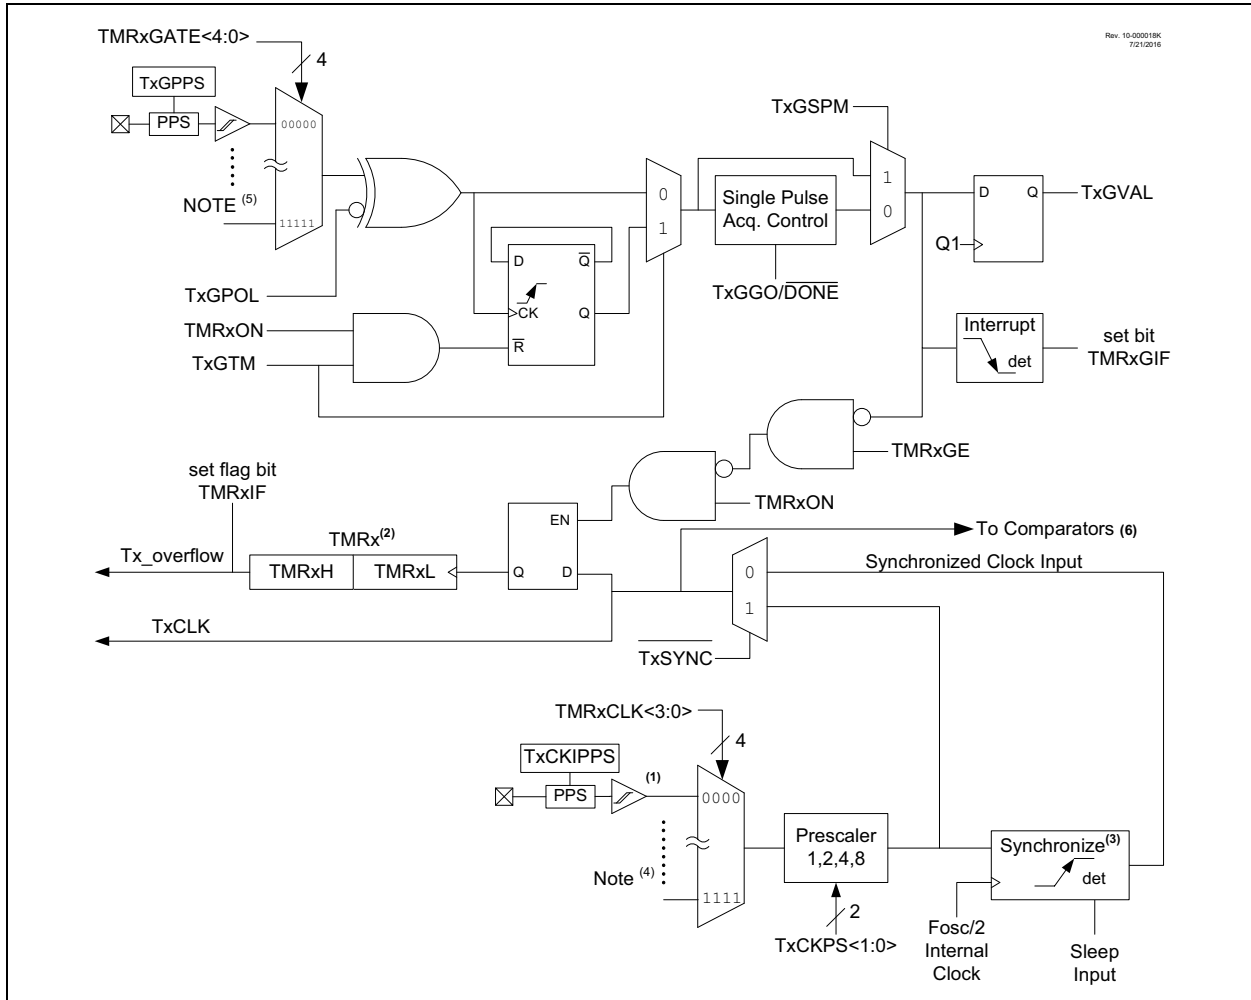
**FIGURE 28-1: TIMER1**

Figure 28-1 is incorrect. The correct diagram is below:

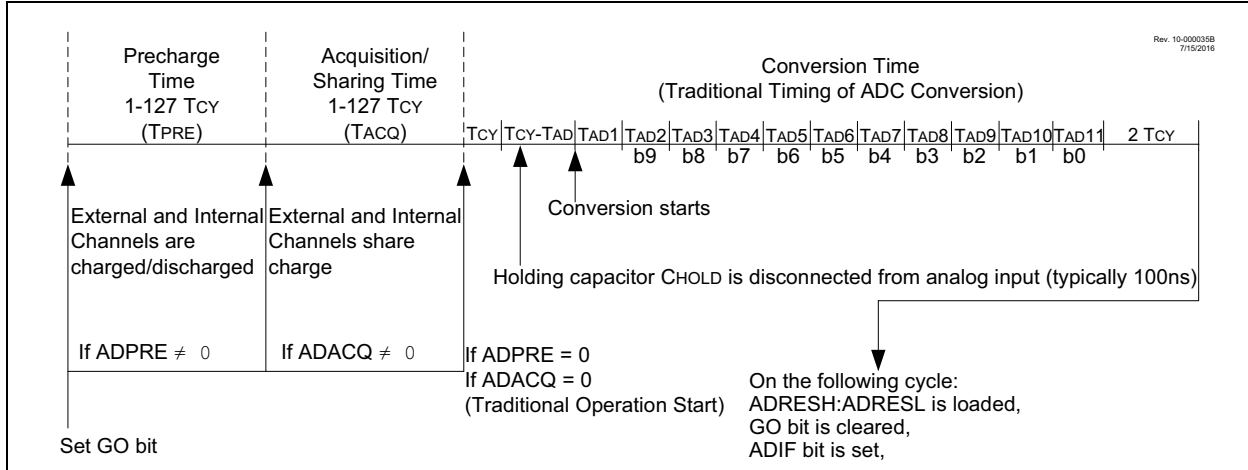
FIGURE 23-2: ANALOG-TO-DIGITAL CONVERTER WITH COMPUTATION (ADC<sup>2</sup>)

Figure 23-2: Analog-to-Digital Converter with Computation (ADC<sup>2</sup>) is inaccurately described in the data sheet for the ADCC. It should be as follows:
