## PIC32MK General Purpose and Motor Control (GP/MC) Silicon Errata and Data Sheet Clarification

The PIC32MK General Purpose and Motor Control (GP/MC) family of devices that you have received conform functionally to the current Device Data Sheet (DS60001402D), except for the anomalies described in this document.

# PIC32MK GP/MC Family

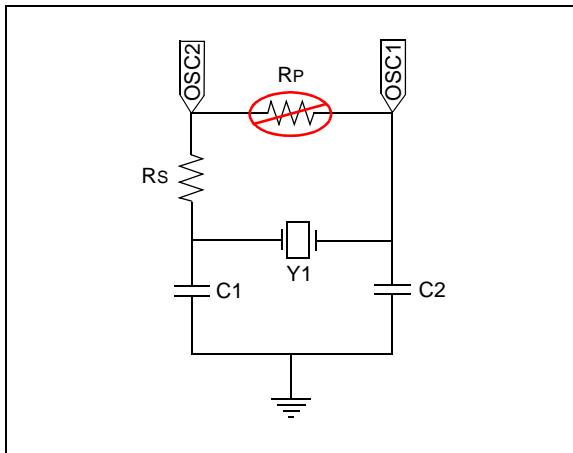
**FIGURE 1: Posc CRYSTAL CIRCUIT**

The Posc supports only specific crystal operation, as provided in [Table 3](#).

The Primary Oscillator (Posc) has been characterized to operate at 8 MHz and 12 MHz when the circuit shown in [Figure 1](#) is implemented and the operating conditions provided in [Table 3](#) are met.

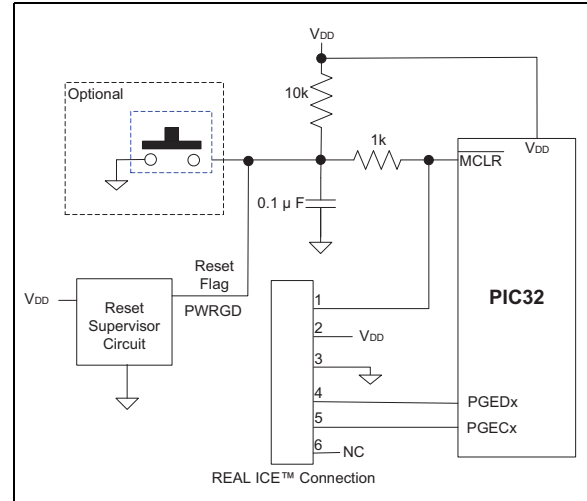
**FIGURE 2: RESET SUPERVISOR CIRCUIT**

On a BOR event,  $V_{POR} < V_{DD} < V_{BOR}$ , a Reset is not generated when the BOR threshold is reached. System clocks will stop with all I/O pins functions frozen in their present state until either  $V_{DD}$  falls to  $V_{POR}$  or  $V_{DD}$  returns to above  $V_{BOR}$ . The user must assess if this  $V_{DD}$  brown-out condition and the resulting frozen I/O pin state has an adverse effect on their application (UART, PWM, I/O, OC, etc.).

If the application can sustain frozen I/O states for  $\sim 2.1$  ms (UART, CAN, I/O, etc.), the application must enable the Deep Sleep Watchdog Timer and Clock Fail Monitor, based on the details provided in Table 5 and Table 6. If implemented correctly, after  $\sim 2.1$  ms, a valid internal reset state is entered and the I/O pins are set to the device default Reset state.
